# Manhole Inspection Summary

Manhole # S45E\_\_030MH

Insp Date: **7/22/08 11:11 AM**

**Location** Address: **Ann**

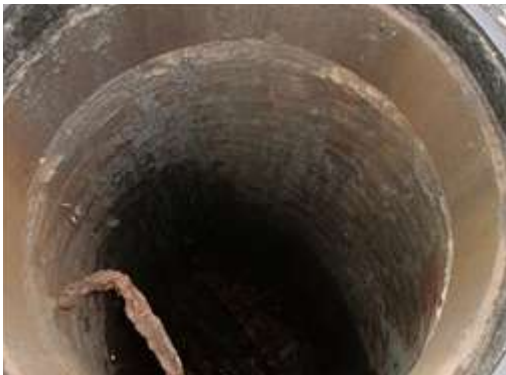
Defect 1

Infiltration: ☐ None ☐ Joint ☐ Cracks ☐ Mortar ☐ Roots ☒ **Wall**

Infiltration

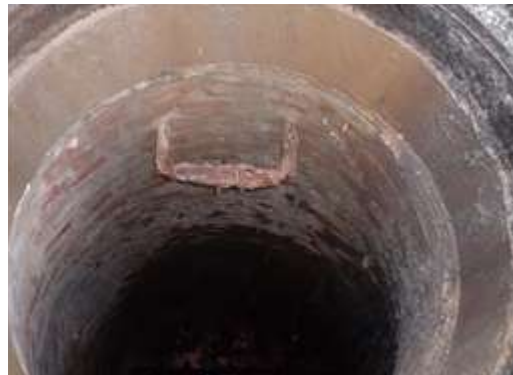
Defect 2

**Frame** Offset: **1** (in.) Condition: ☐ Sound ☐ Cracked ☒ **Leaks**

Frame Leaks

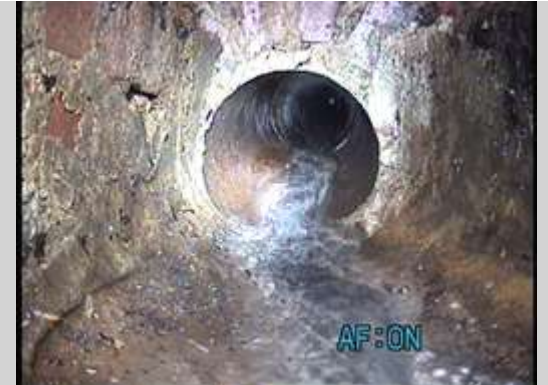
12 O'Clock Outflow

8 in. Circular Gravity Sewer  
Pipe Out @ 12 O'Clock

Pipe Height: **8.4** (in.) Rod and Bar (Angled)  
Pipe Material: **Clay** ☐ Pipe Lined  
Invert Depth: **10.60** (ft.) Flow Characteristics: **Fast**  
Deposits: ☒ None ☐ Mud ☐ Sludge ☐ Debris ☐ Grease  
Silt Depth: (in.) Deposits Extent:  
Infiltration: **None** Pipe Seal Cond: **Sound**

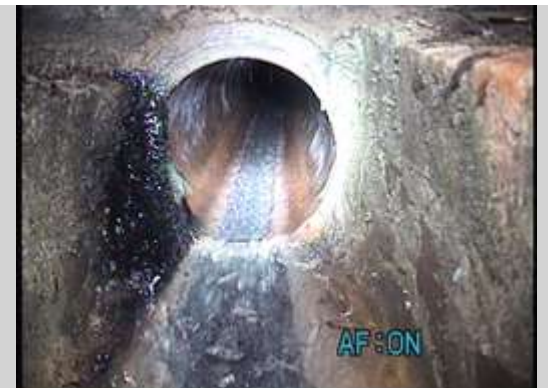
6 O'Clock Inflow

8 in. Circular Gravity Sewer  
Pipe In @ 6 O'Clock

Pipe Height: **8.4** (in.) Rod and Bar (Angled)  
Pipe Material: **Clay** ☐ Pipe Lined  
Invert Depth: **10.20** (ft.) Flow Characteristics: **Fast**  
Deposits: ☒ None ☐ Mud ☐ Sludge ☐ Debris ☐ Grease  
Silt Depth: (in.) Deposits Extent:  
Infiltration: **None** Pipe Seal Cond: **Sound**
